VTX110ci Wax Valve Info with pix on this thread Posted 5/14/2015

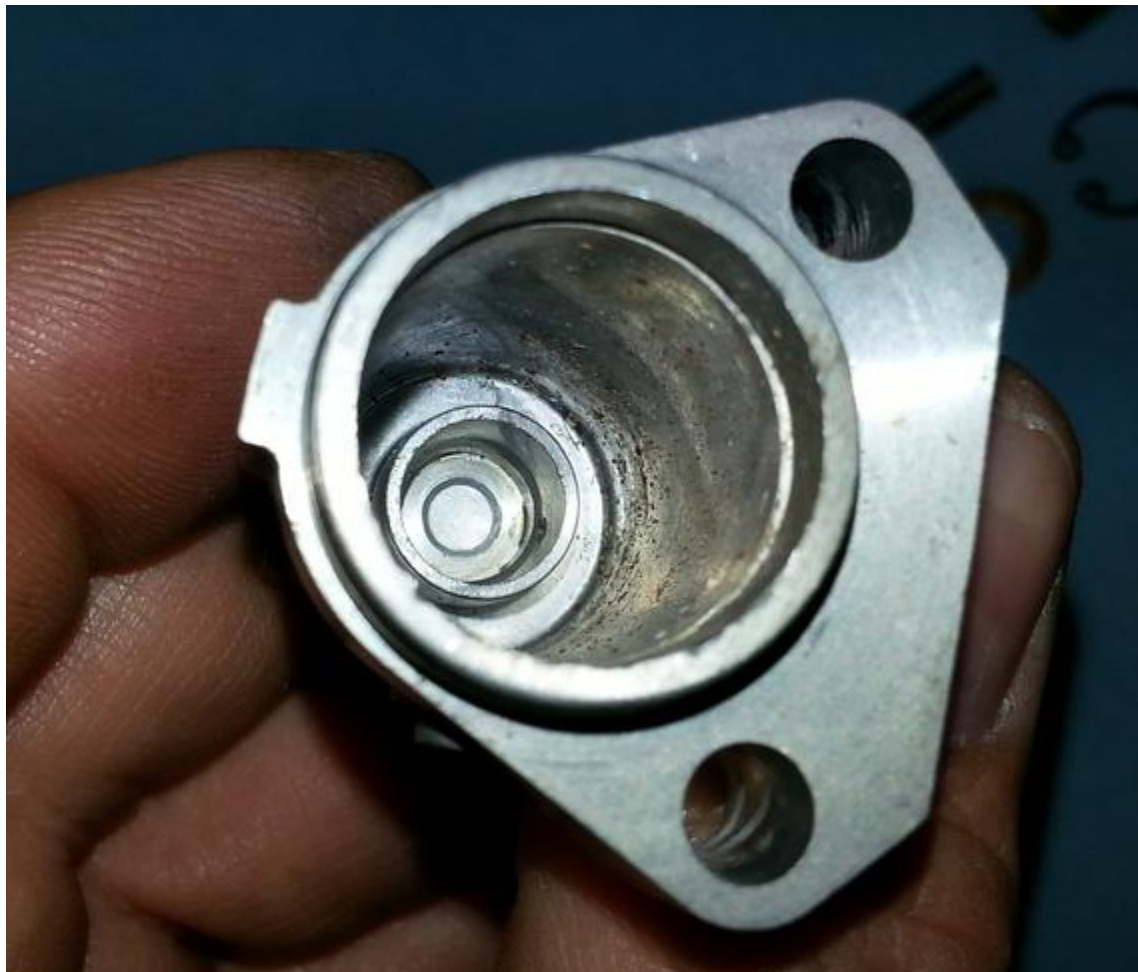
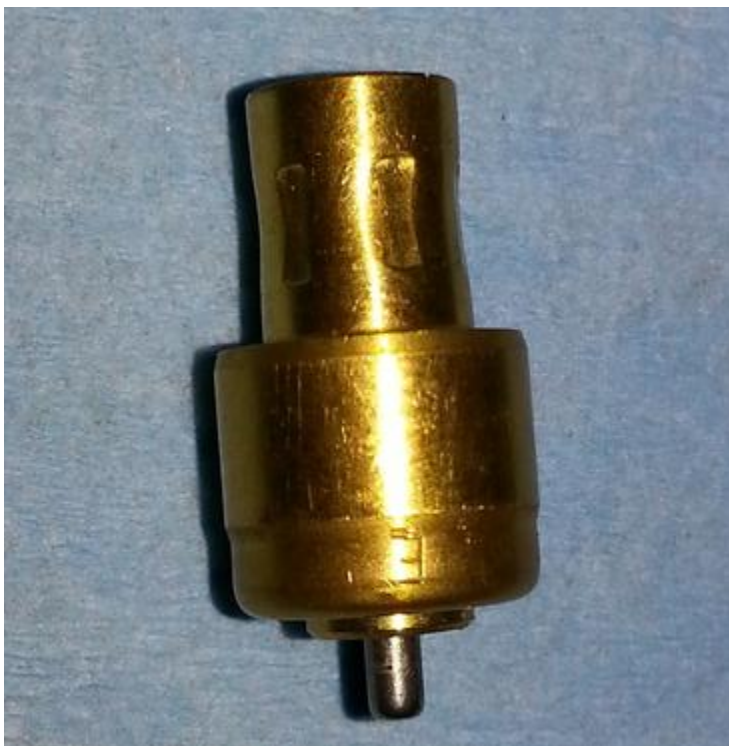
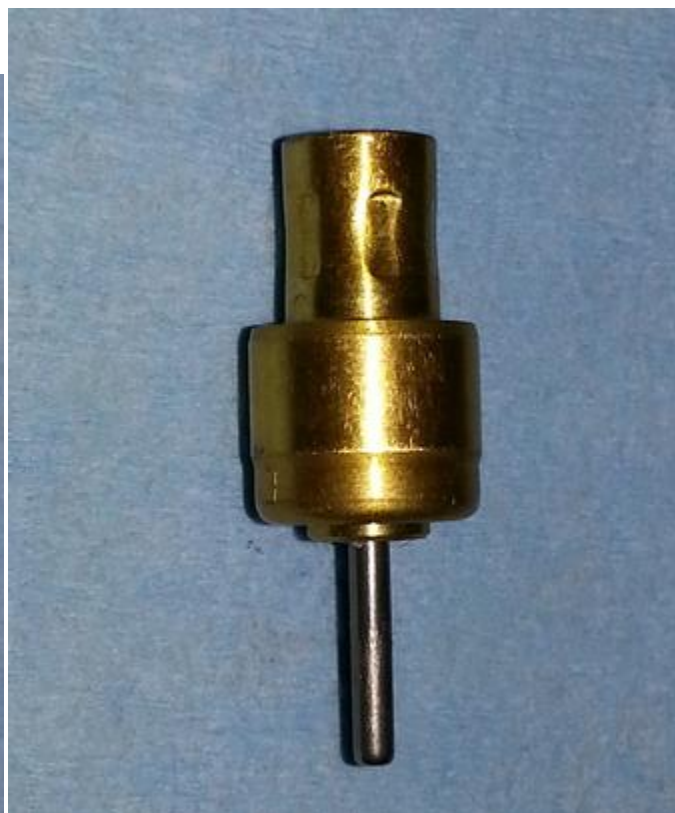
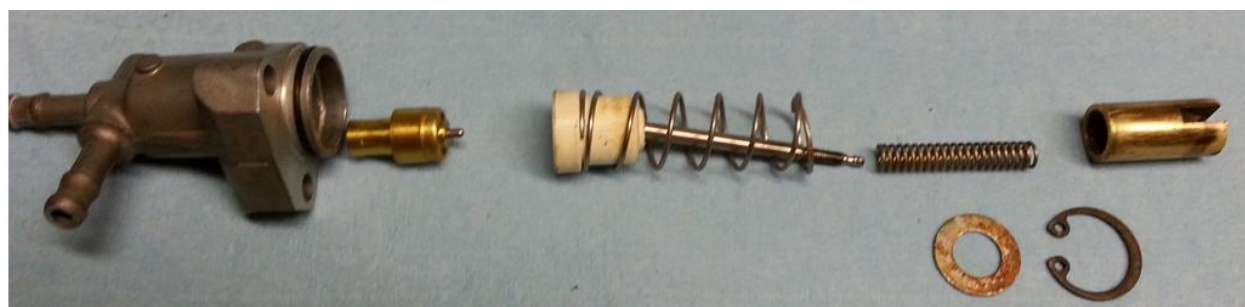
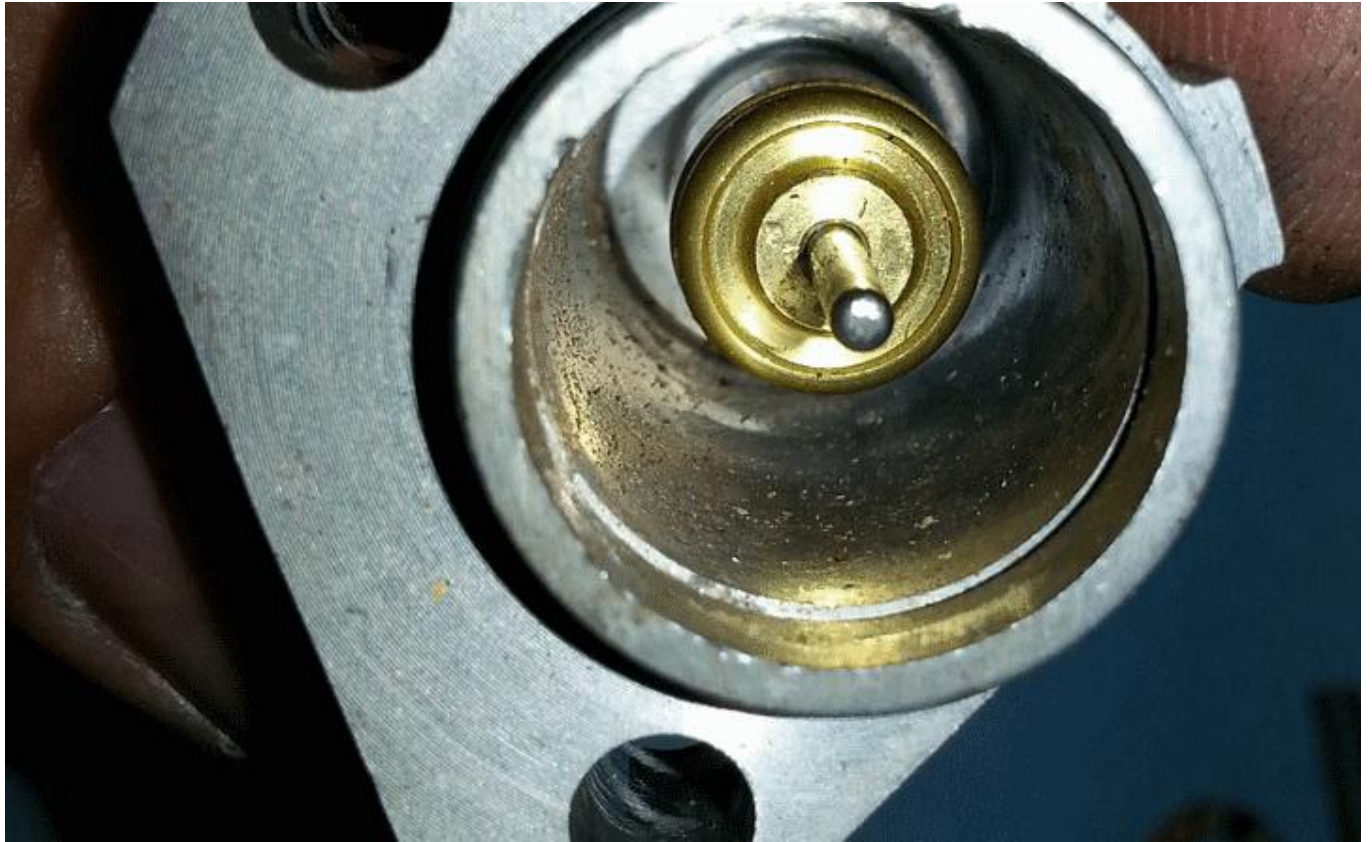
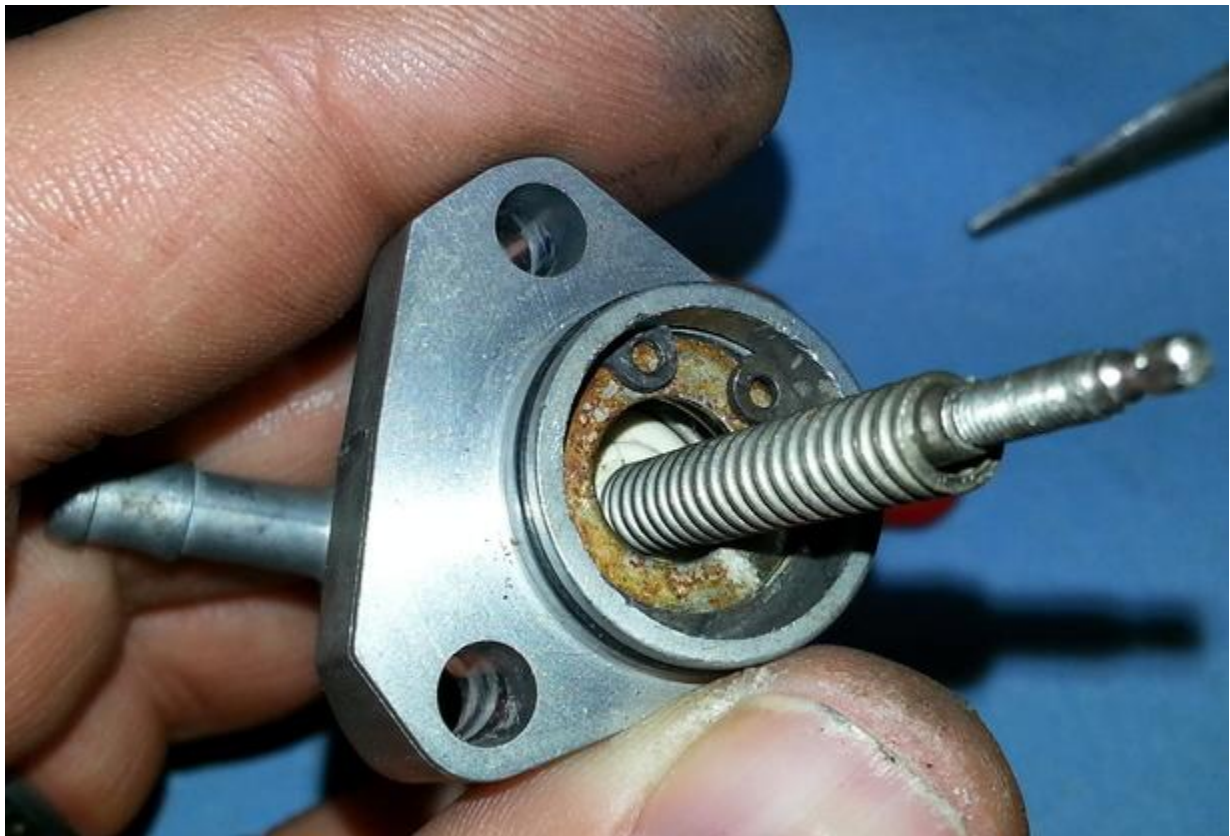
Ok, pics of wax valve disassembled. The coolant passes through the back but never is inside the valve. The coolant transfers heat to the brass thing with the pin and as it heats up the pin extends out of it pushing against the threaded rod/pin the valve cylinder is on pushing it out until it is stopped by the pin to control our idle. There's two air holes that when cold and the cylinder is back allows more air into the throttle body allowing for a higher idle. As it moves out it blocks those holes off dropping the idle down to whatever it is set at by the idle adjustment.

I completely disassembled a wax valve and not what I thought inside. The coolant heats up the housing and there is a pin inside and as it heats up pushes the cylinder you see out. No coolant is behind that cylinder. I'll have to take it apart tonight and post pictures. The pin was stuck, I pulled it out then put it back in reassembled and tested it in water on the stove and operated as it should. I have a spare lying around I can take apart tonight.
